Fire Dynamics During the Channel Tunnel Fires

Ricky Carvel
BRE Centre for Fire Safety Engineering
University of Edinburgh

ABSTRACT

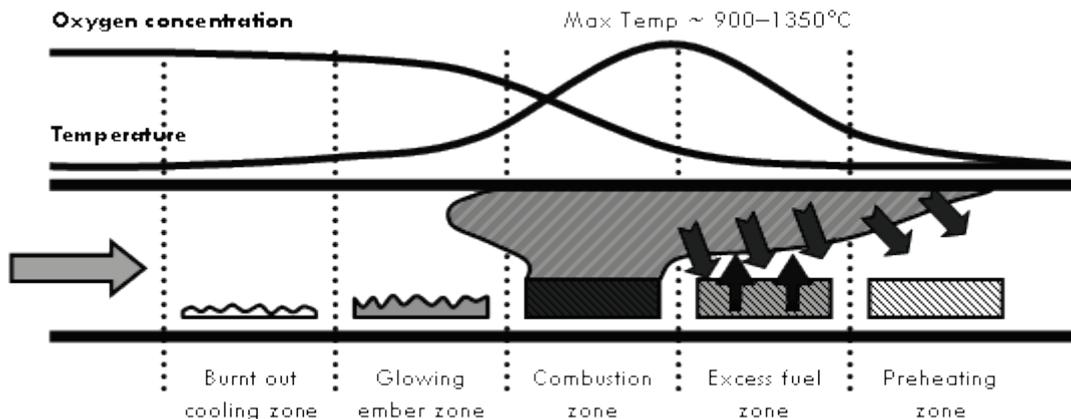
Figure 3 The conventional model of catastrophic tunnel fires, based on Ingason

The basic concept is that there is a fire travelling along a line of vehicles in the direction of ventilation flow. The fire consumes fuel as it progresses, but the extent of the combustion zone is limited by the amount of fresh air supplied by the (forced) ventilation system.

It is only during the periods of relatively low flow (i.e. after the train had stopped) that the fire behaviour would follow Ingason's pattern. Under these circumstances, a zone of hot, unburned, gaseous fuel would be produced downstream of the fire location. If, after this zone of hot fuel developed, the ventilation conditions in the tunnel were changed – either by reversing or increasing the flow – these hot flammable gases would mix with fresh air and this would lead to very rapid burning, perhaps even an explosive event analogous to backdraught in compartment fires.

It is proposed that these rapid burning events in the 1996 and 2008 Channel Tunnel fires lead to rapid fire spread between wagons, possibly across several wagons at a time. It may be that the 2006 fire did not spread in the same way because there were no reversals of flow or increases in flow during the incident.

1. If it is necessary to stop the train in the tunnel, the emergency ventilation system should be activated and allowed to become fully established before the train is signalled to stop. This would mean that the fire would never experience a reversal in flow direction or a period of very low flow.
2. If a train on fire is stopped in the tunnel and is subject to a longitudinal airflow, the airflow velocity should not be increased after the fire has become well established.
3. Given that fire growth and spread appears to be slower on a fast moving train, compared to one that is stopped, consideration should be given to drive the train out of the tunnel before stopping.

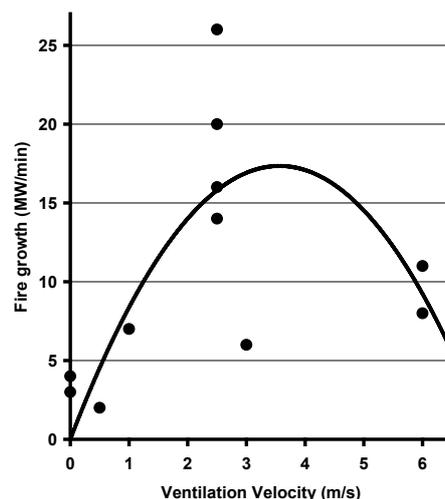
Figure 4 The apparent relationship between fire growth rate and ventilation velocity [11].

It has previously been observed that the rate of growth of a fire in a tunnel is dependent on the ventilation rate [10,11]. While no experimental fire tests have been carried out in tunnels with ventilation flow rates above about 6 ms^{-1} , such information as is available suggests that there is a decline in growth rate with increasing velocity, for ventilation velocities above about 4 ms^{-1} , see

Figure 4. Thus it is likely that the fire would not have grown very large while the train was moving at high velocity.
